TAQA North Ltd.
Well Blowout
10-10-28-29W4M
June 8, 2009

ERCB Investigation Report

January 11, 2010

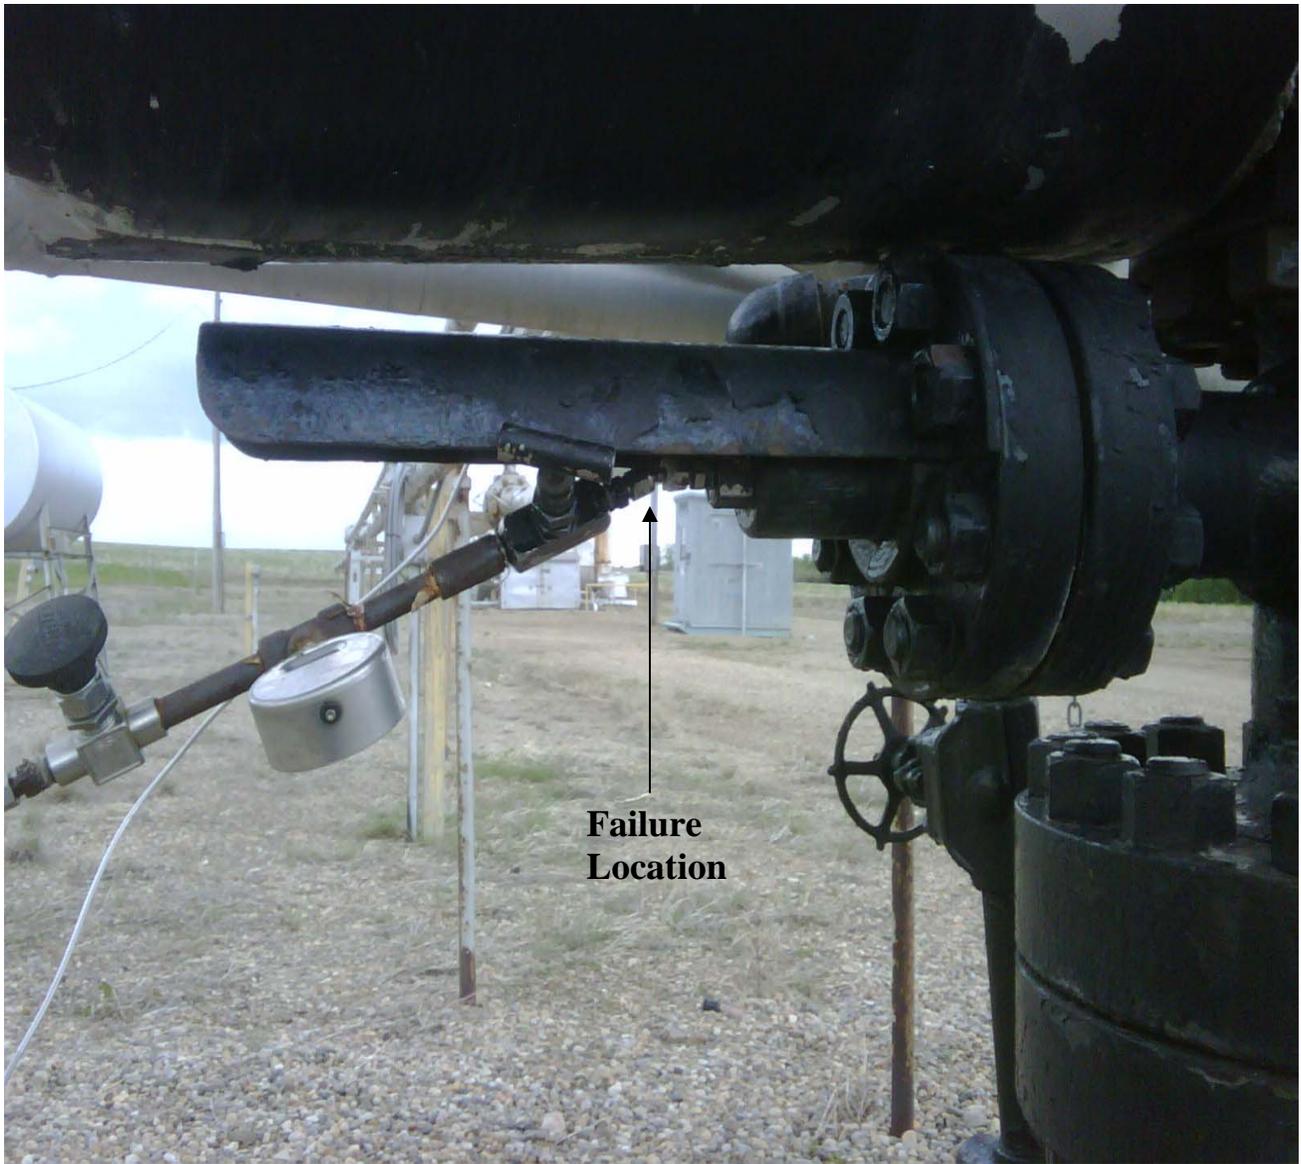
Figure 1. Failed hydraulic control line

The contractor was conducting a packer isolation test in accordance with Energy Resources Conservation Board (ERCB) requirements and evaluated the wellhead to determine the best way to obtain the necessary well and annulus pressures. The contractor noted that there was a circulation string tied into the casing on one side of the wellhead and a 1/4 inch (6.35 millimetre) hydraulic control line (see Figure 1) coming out of the casing on the other side.

TAQA sent the failed section of tubing to Acuren Group Inc. (Acuren) for inspection and testing. Acuren concluded that the 1/4 inch control line failed in a ductile overload mode as a result of the application of excessive bending stress. Acuren said that there was no evidence to suggest that environmental cracking or corrosion played a significant role in the failure.

The well was declassified from "critical sour" on July 22, 1991. The 1/4 inch line was the hydraulic control line to a subsurface safety valve (SSSV) that had been removed by a previous licensee. This removal allowed wellbore pressure to remain on the line to the surface.

Well control operations continued, and at 4:43 p.m. all flow from the well ceased. TAQA replaced the line that failed with a new line and valve. Once no H₂S readings were detected, TAQA and the ERCB called the incident down, and TAQA notified all affected parties that the incident was over.
