**Daylight Energy Amalgamationco Ltd.
Sour Gas Release
Surface Location 06-23-047-10W5M
December 16, 2009**

ERCB Investigation Report

July 21, 2010

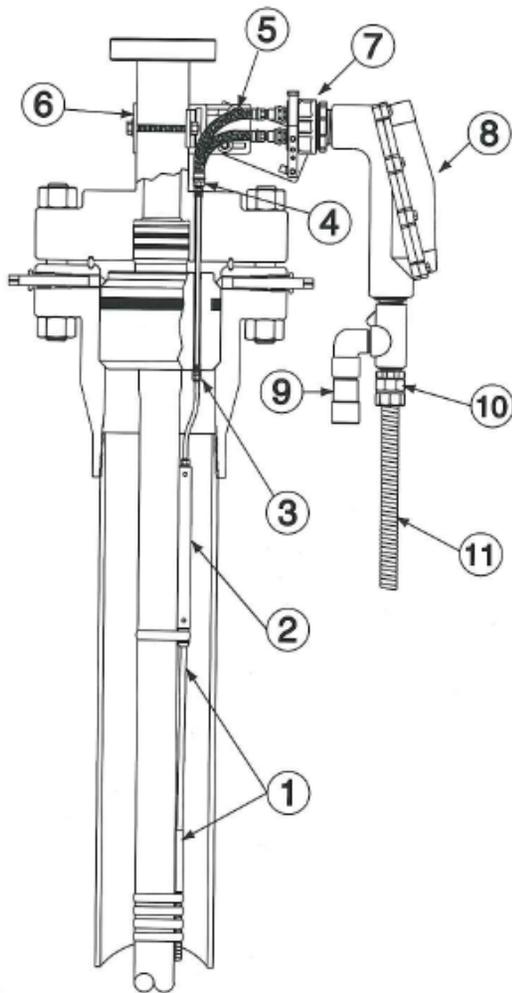
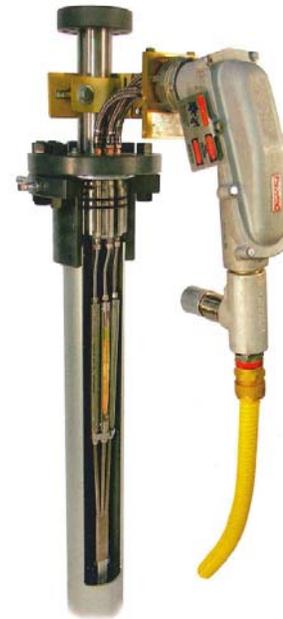
Figure 2. Diagrams of heat tape assembly

After the well was killed, Daylight observed damage to the heat tape assembly. There was visible damage to two of the three connectors in the connector assembly (see Figure 2, number 2), mostly on the centre connector. Additionally, one of the three wires and a section of the stainless steel tubing were missing from below the tubing hangar (see Figure 2, number 3). The heat tape was detached at the top of the bracket assembly (see Figure 2, number 6), and a gasket was pushing out of the surface junction box (see Figure 2, number 8). For photos of the damages, see Figure 3.

The excessive heat of the short circuit destroyed the centre connector, allowing downhole gas pressure to push the wire located inside the connector to surface. This connector wire was found burnt off and wadded up in the surface junction box. The pressure was too high for the bracket assembly seal, and the seal ruptured. Gas was released from that seal, as well as the centre port at location 4 in Figure 2.

- 1. Triskelion
- 2. Connector assembly, made up of three connectors (failure point)
- 3. Bottom seal fitting
- 4. Top seal fitting (gas release point)

- 5. Flexible fitting
- 6. Bracket assembly (gas release point)
- 7. Three-inch union
- 8. Surface junction box
- 9. Detonation arrestor
- 10. Cable terminator fitting

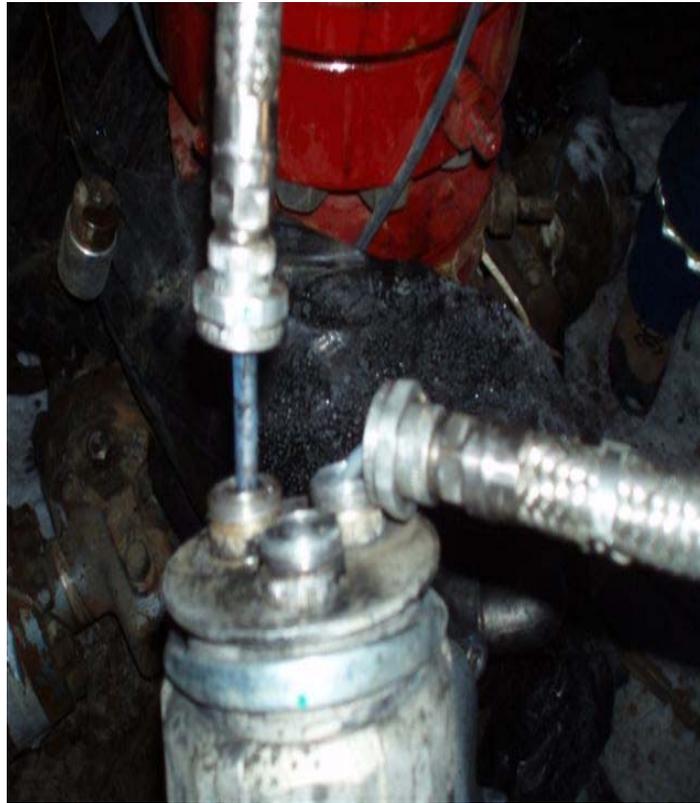
Figure 3a. Cable assembly detached at top of bracket assembly

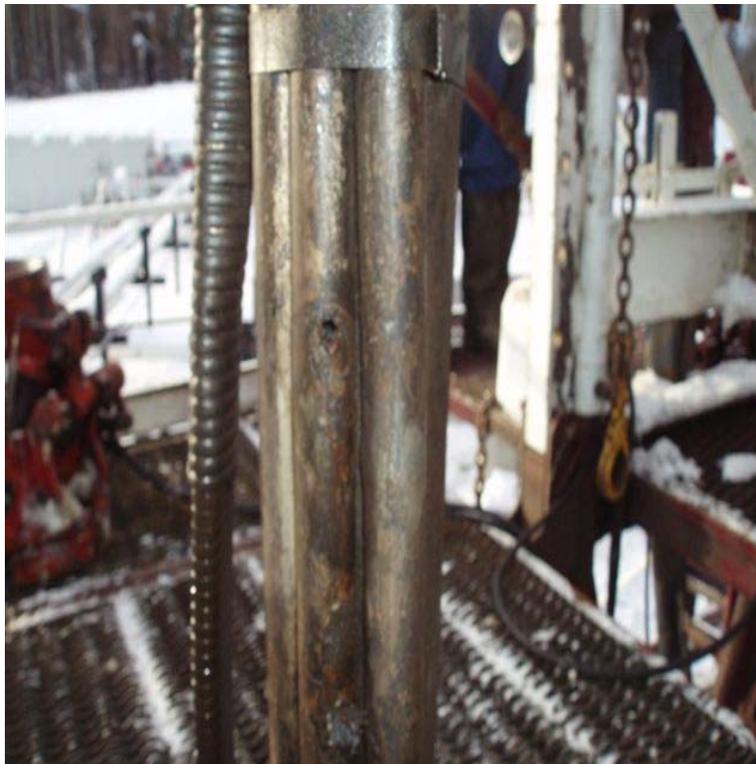
QCI found that the failure was caused by excessive temperature created by a short circuit in one of the wires located in each connector. The outer two connectors did not show signs of excessive heat; however, the components in the centre connector were completely charred, indicating temperatures in excess of 500°F. The short was most likely above the connector assembly, directing the current from the outer two legs back through the grounded centre leg. This created a current overload and excessive heat.

Figure 3b. External damage to connector assemblies

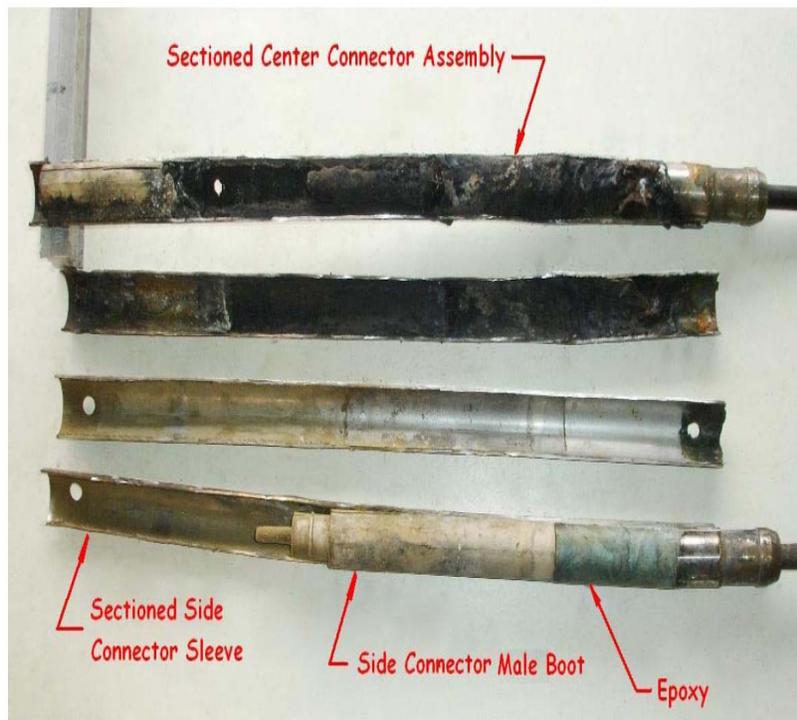
Daylight and QCI agreed that a short circuit could be caused by contact with H₂S gas leaking into the connector assembly and damaging the wires or by a blown or faulty fuse in the connector assembly. Because of the extensive heat damage to the interior of the centre connector (see Figure 4), neither Daylight nor QCI were able to conclusively determine the cause of the short circuit.

Figure 4. Comparison of damaged connector vs. undamaged connector
